STOPBANK PERFORMANCE DURING THE  
2010 – 2011 CANTERBURY EARTHQUAKE SEQUENCE

A thesis submitted in partial fulfilment of the requirements for the Degree  
of Master of Science in Engineering Geology

Sophie Elizabeth Bainbridge

2013

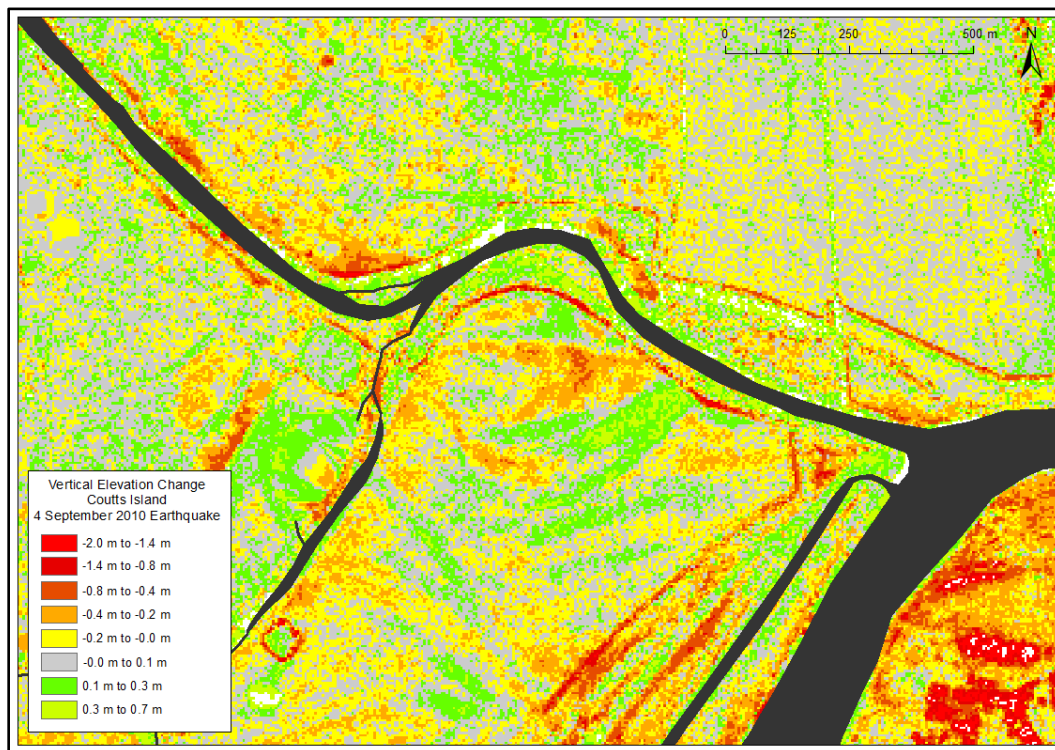
Along the Kaiapoi and Waimakariri River the LiDAR data set following the 4 September 2010 Earthquake shows a range from no settlement up to -2.0 m settlement. Interestingly, the LiDAR clearly shows in many locations settlement of the stopbank being significantly greater than settlement of the surrounding native ground. This generally occurs in areas where the stopbank is larger in size and therefore heavier and more compressible, for example on Coutts Island, east of Kaiapoi, where the stopbanks along approximately 1.6 km of the river settled by -0.8 m to -2.0 m relative to the surrounding ground that settled by up to -0.4, for stopbanks approximately 2 m high, following the 4 September 2010 Earthquake as shown in Figure 23. LiDAR following the 22 February Earthquake is not as useful as restoration works had begun and in the places where damage occurred multiple times in the WEC system, the stopbank levels had been built up to generally higher than previous levels, showing an apparent rise in elevation of 0.3 to 0.5 m in many places, and the seismic demand was lower.

FIGURE 23: COUTTS ISLAND (KAIAPOI) EXAMPLE OF STOPBANK SETTLEMENT BEING SIGNIFICANTLY GREATER THAN THAT OF ADJACENT NATIVE SOILS.

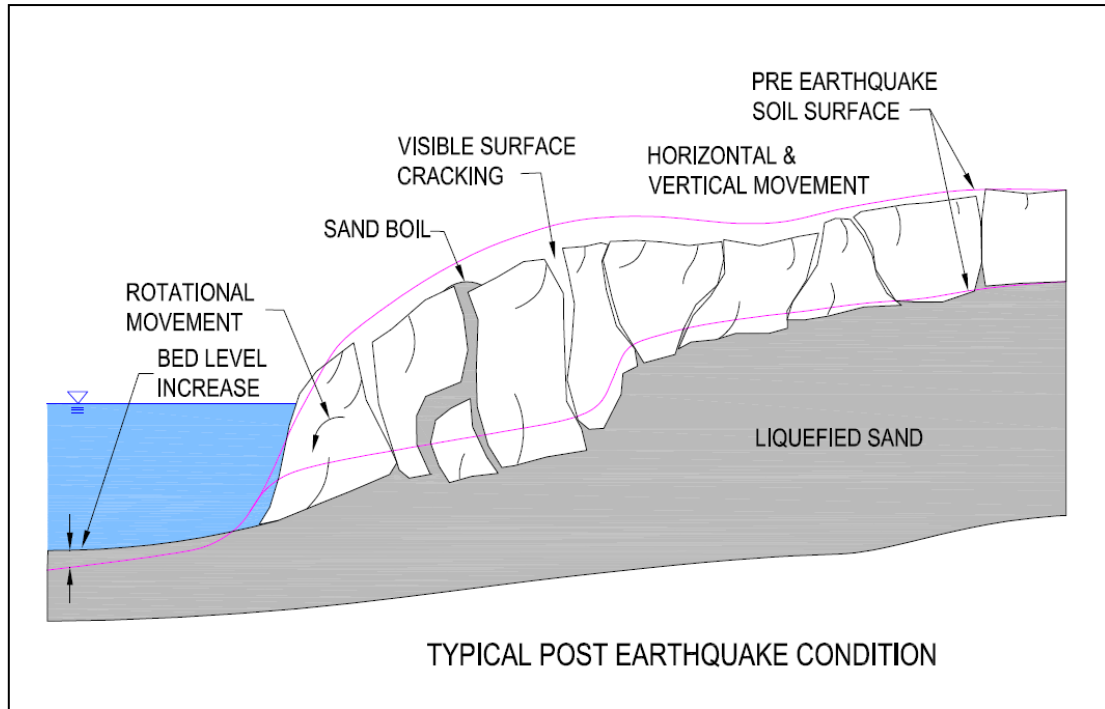
Figure 30 and Figure 31, taken from McCracken and Surman (2012), illustrate the failure mechanism associated with the reduction in waterway capacity. Figure 31 demonstrates how flow into the river from a liquefied sand layer and outwards rotation of the native river bank has caused an increase in the height of the bed of the river. This same manifestation is seen in both the Avon and Kaiapoi Rivers.

FIGURE 31: TYPICAL HALSWELL RIVER BANK CONDITION AFTER THE SEPTEMBER EARTHQUAKE EVENT (MCCRACKEN AND SURMAN, 2012)

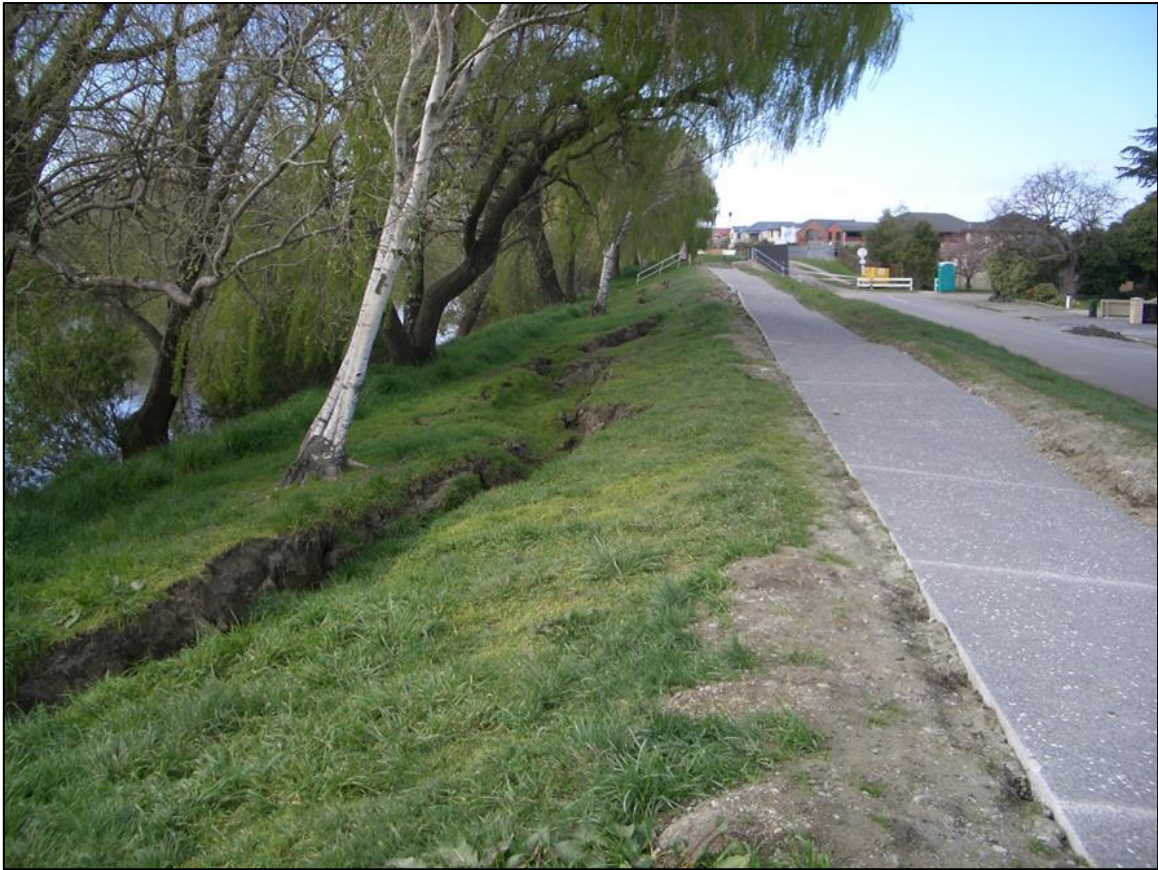
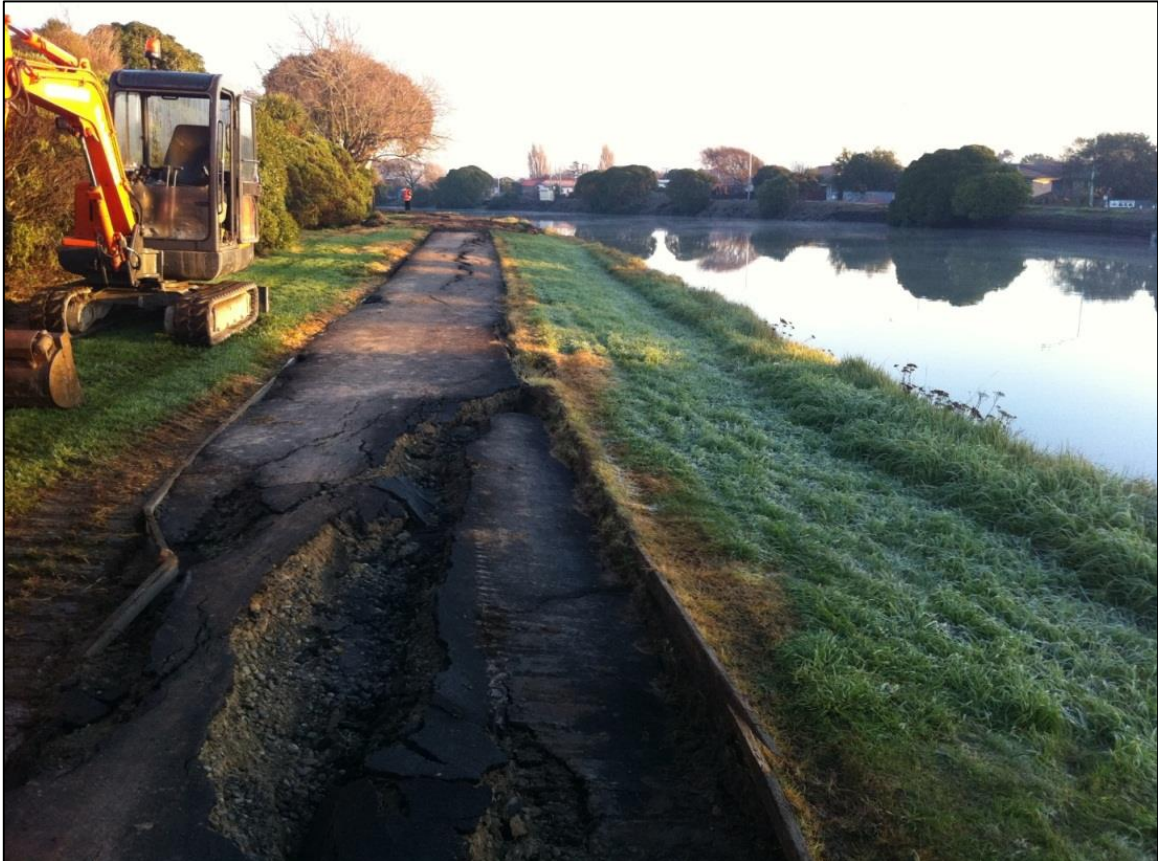
Slumping generally occurs in stopbanks adjacent to the river, or a marshland, as the mechanism generally requires large lateral movements of the liquefied foundation towards a free face or loss of soil volume and potential bearing support in the foundation soils. This deformation mechanism is associated with liquefaction of the foundation and in the majority of cases occurs where liquefaction ejecta is present, with significant thickness of liquefiable materials from the water table to depths of 6.5 m to 10 m.

**FIGURE 45: EXAMPLES OF SLUMPING DEFORMATION (DM3-S). PHOTO 1 (KAIAPOI SOUTH BANK) PROVIDED BY ENVIRONMENT CANTERBURY; PHOTO 2 (AVON RIVER SOUTH BANK) PROVIDED BY GHD.**

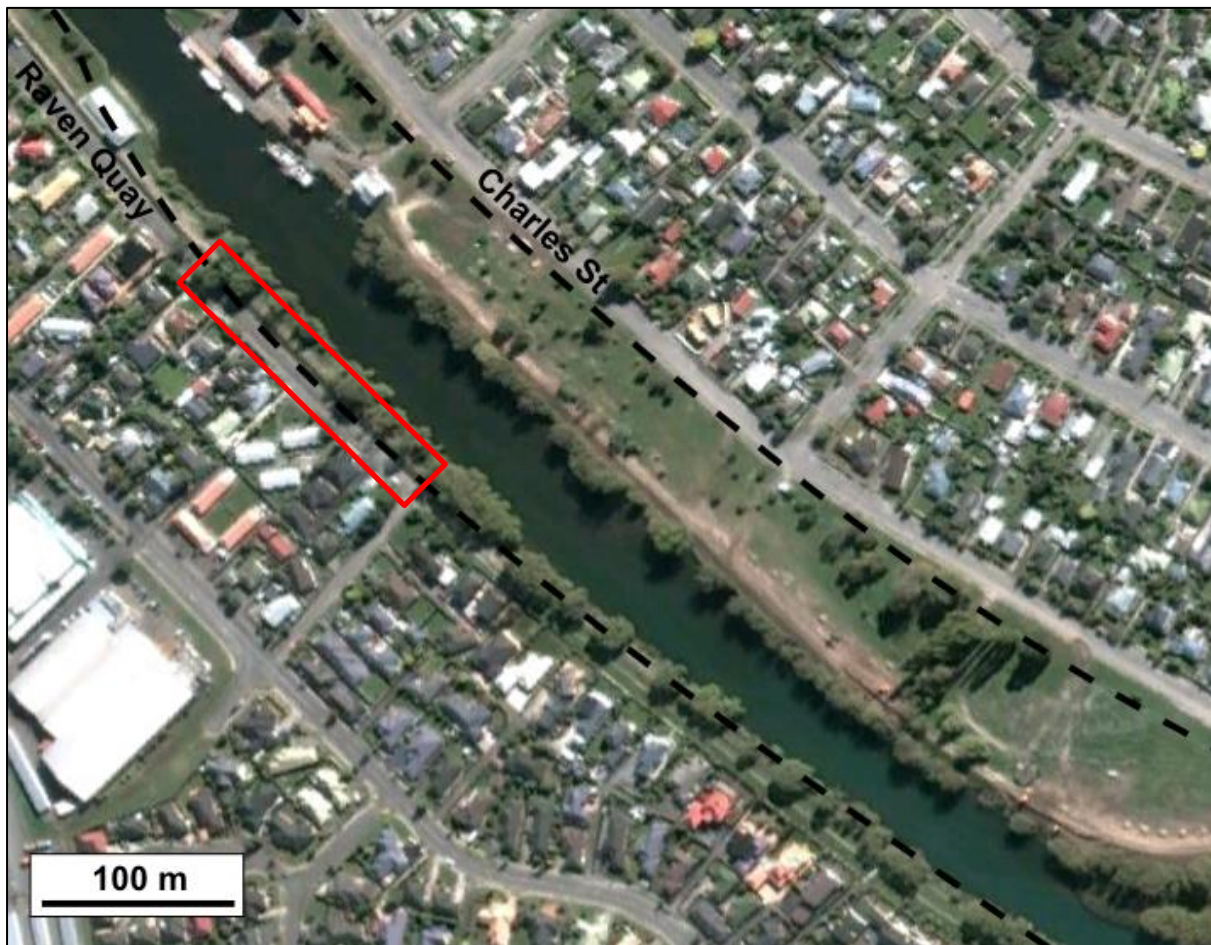
In one location, the foundation of the stopbank has split longitudinally in to two different material types, as a result of narrowing of waterways along Raven Quay, with part of the stopbank constructed on the old river bank and part on the old river. This area is outlined in Figure 46 and the damaged length of river is shown in Figure 45 – Photo 1. The part of the stopbank constructed on the reclaimed or narrowed channel has slumped into the old river. The other half of the crest and the landside batter that have been built on the old riverbank have performed well. This differential performance illustrates the wide variety in foundation conditions adjacent to the rivers that may not necessarily be picked up through geotechnical investigations due to a lack of density of geotechnical investigations, but are understood due to the nature of reclaiming land along river edges.

**FIGURE 46: AERIAL PHOTO INDICATING 1865 KAIAPOI RIVER BANKS, RED BOX INDICATES ZONE OF PARTIAL SLUMPING.**

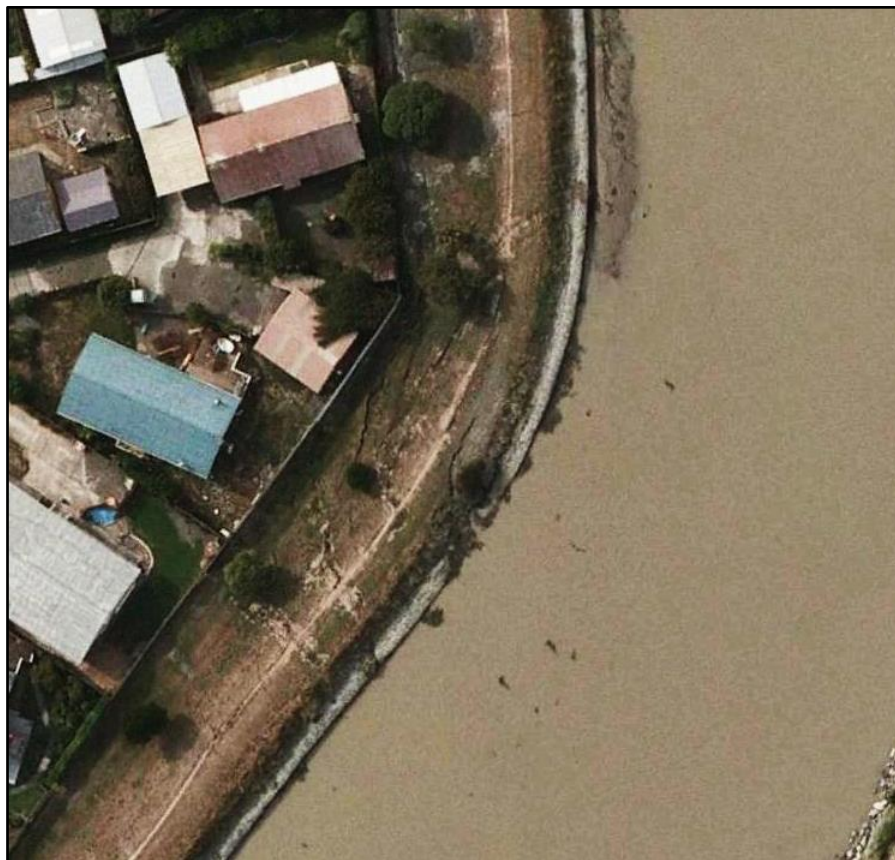
**FIGURE 47: PLAN VIEW OF CORNER SLUMPING DEFORMATION ON THE AVON RIVER, APPROXIMATELY 1.3 KM NORTH OF AVON-HEATHCOTE ESTUARY MOUTH (CGD 0100)**

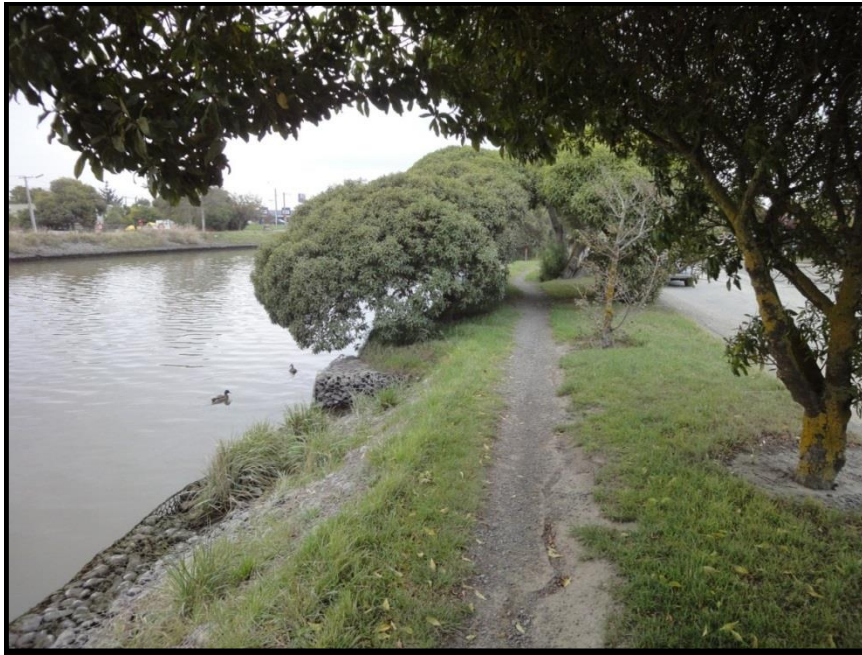
**FIGURE 54: SETTLEMENT OF GABION BASKET AND SLUMPING OF RETAINED LAND**

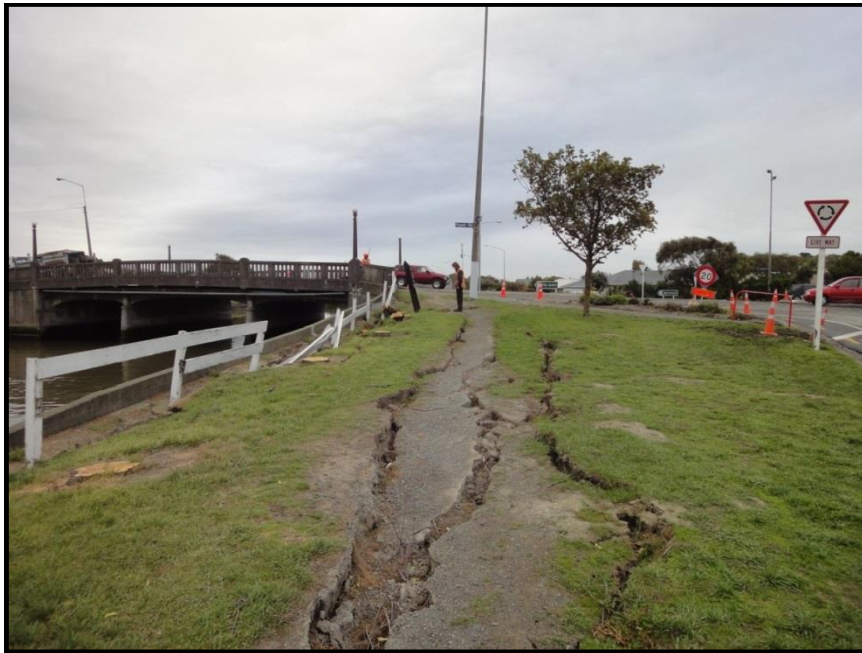
**FIGURE 55: SLUMPING OF LAND BEHIND REINFORCED CONCRETE RETAINING WALL, WALL HAS BULGED OUT SLIGHTLY AND THERE ARE MINOR CRACKS**

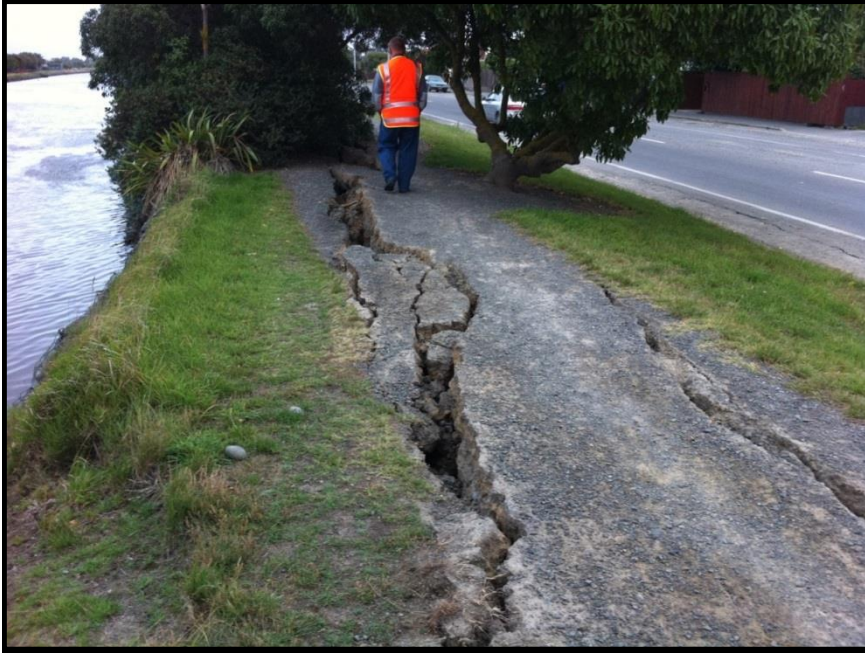
**FIGURE 56: OUTWARD ROTATION OF GABION BASKET AND ASSOCIATED SLUMPING OF RETAINED LAND**

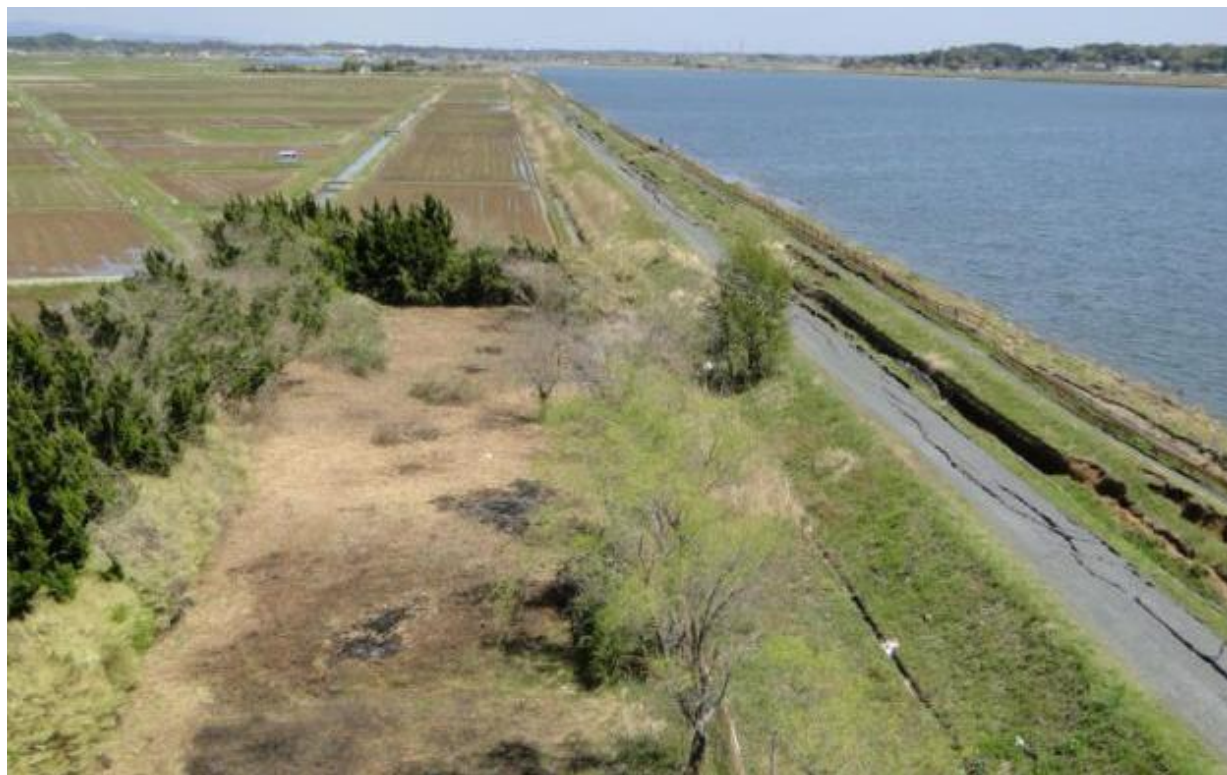
**FIGURE 1: VIEW OF SLUMPED HINUMA RIVER LEFT STOPBANK INDUCED BY LIQUEFACTION (N36.2861, E140.5238., APRIL 24, 2011).**

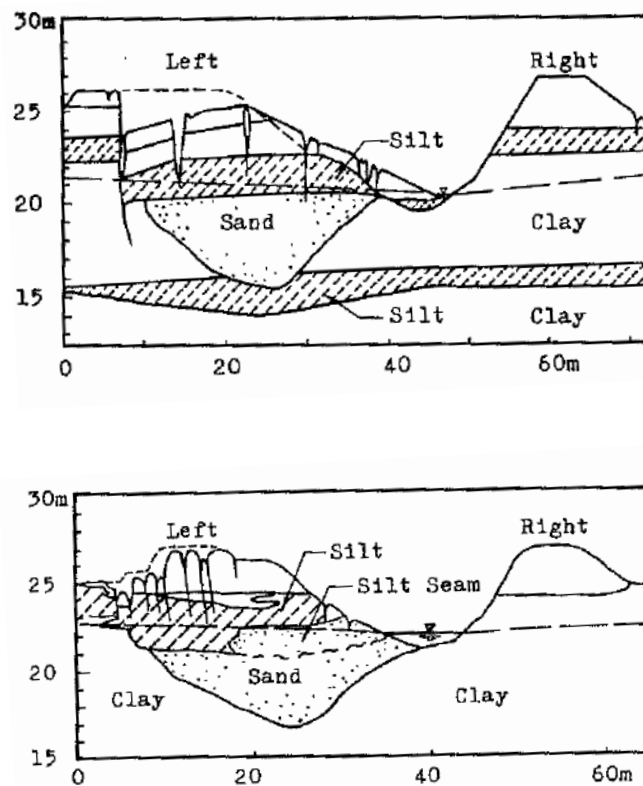
FIGURE 3: DAMAGE OF FUYANG RIVER BANK AND STOPBANK DUE TO LIQUEFACTION OF SATURATED SAND POCKETS

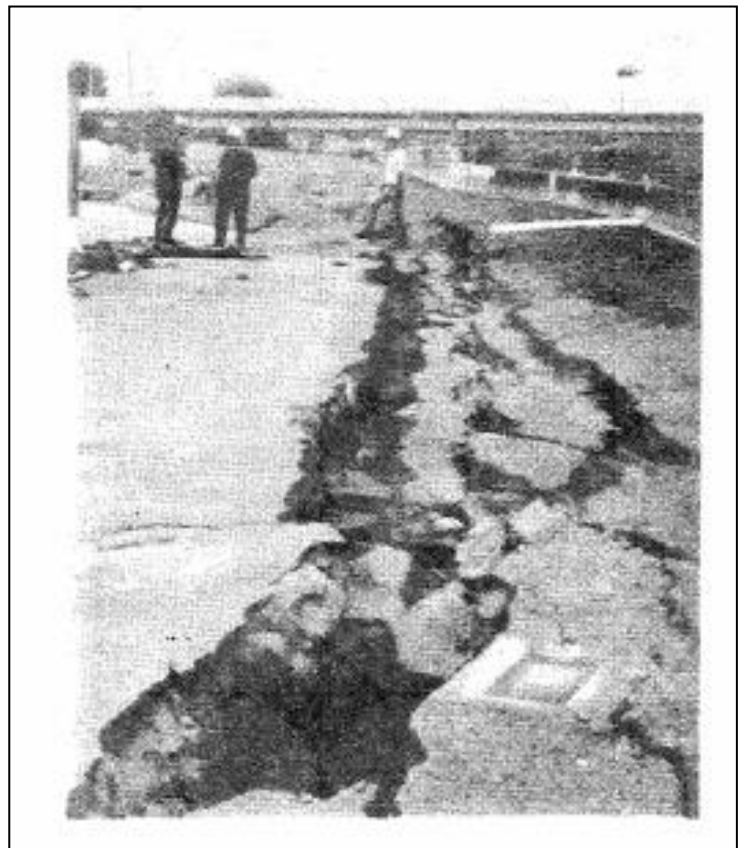
**FIGURE 5: THE TRUE RIGHT STOPBANK OF THE RANGITAIKI RIVER IN EDGECUMBE AFTER THE 1987 EARTHQUAKE**

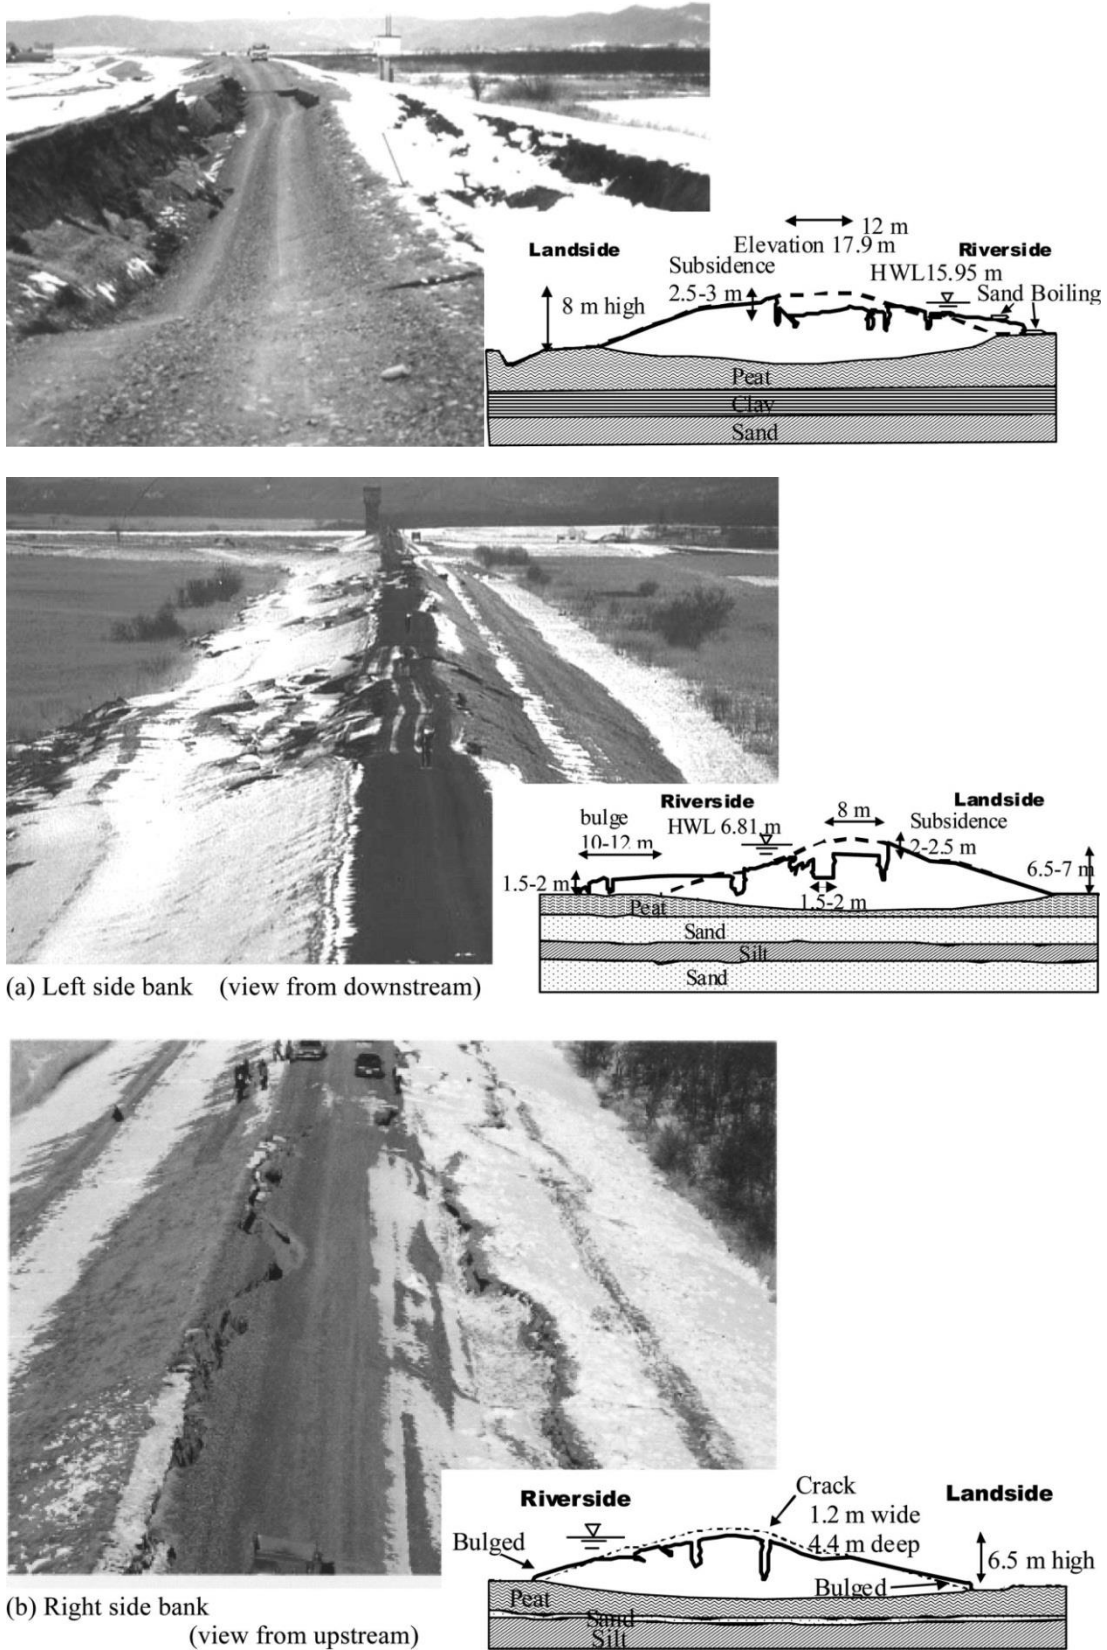
FIGURE 8: TYPICAL VIEW OF THE FAILED STOPBANK OF THE KUSHIRO RIVER. (SASAKI, 2009)
